ANA Garrison at Kunduz Does Not Meet All Quality and Oversight Requirements; Serious Soil Issues Need to Be Addressed

April 30, 2010

This report discusses the results of a performance audit of two firm fixed-price contracts currently valued at \$72.8 million for the construction of the Afghanistan National Army garrison in Kunduz Province. It includes two recommendations to the U.S. Commanding General of the U.S. Army Corps of Engineers to address construction issues observed at the site and one recommendation to improve oversight.

SIGAR Audit-10-09

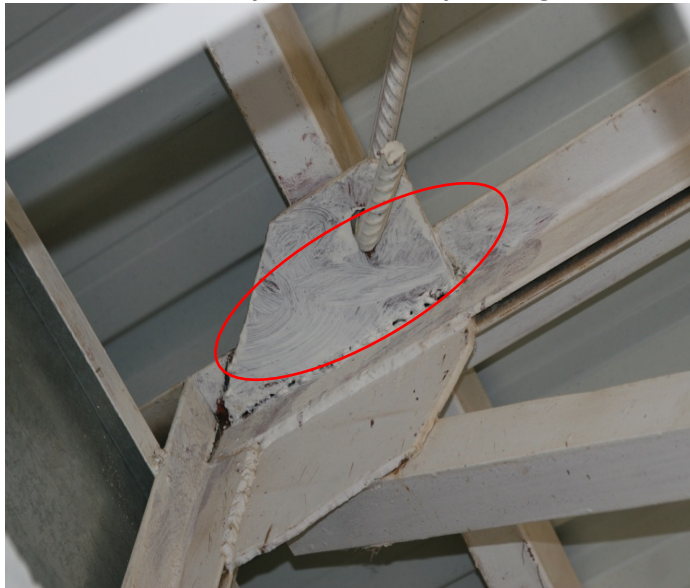
Photo 1: Poor Quality Welds on Sway Bracing at Kunduz ANA Garrison

We observed that welds on sway bracing in barracks and other facilities on the garrison were not in compliance with welding standards as specified in the contract by reference to the American Welding Society code.⁹ We visually inspected the welds and found them to be irregular, filled with holes, and lacking the required continuity or section buildup. The cause appeared to be poor welding technique likely due to inadequately trained welders and poor or non-existent quality control and quality assurance. As a result, the deficient welds create a structural system that is incapable of providing adequate support. A heavy load may cause the sway bracing to fail and the roof to sag or collapse. See photo 1 for depiction of poor welds.

1. Repair the welds and mitigate the rust on steel supports on the affected structures; and
2. Resolve the soil stability issue and determine what mitigation or corrective actions are required for DynCorp to complete the garrison, including ensuring that the site is properly graded.

a. Repair of the welds started several months prior to the SIGAR site assessment, and are now complete. Phase I was completed on Feb 16, 2010 and Phase II was completed on Apr 3, 2010.

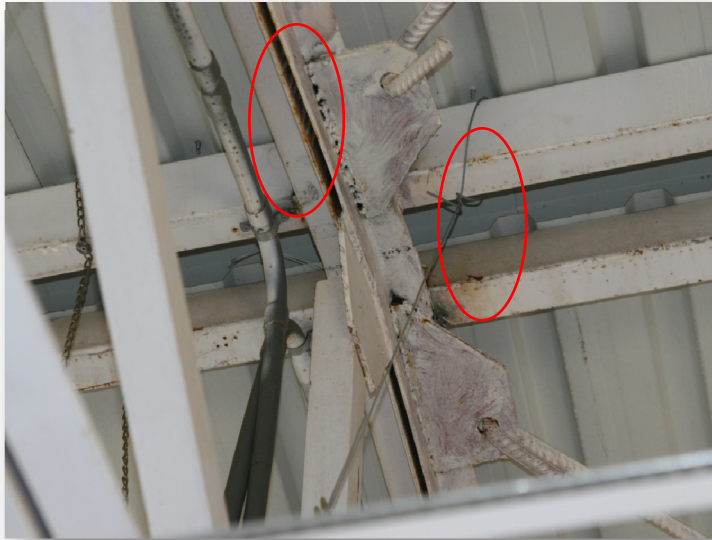
Photo 2: Rust on Steel Supports at Kunduz ANA Garrison

We observed that rust was breaking through the coat of primer that covered the sway bracing and the roof purlins¹⁰ at various locations. Oxidation or rust occurred because the primer coat had been applied too thinly and moisture had formed on the exposed steel. As a result, rust will damage the structural integrity of the steel. At some point, the roof may sag or collapse. See photo 2 for an example of rust on the structural steel.

a. The senior Quality Assurance Representative (QAR) at the Kunduz Resident Office discovered through direct visual inspections that the rust spots were primarily caused by various sections of the roof not being in place during heavy rains in December 2009 (the SIGAR was briefed regarding this issue during the site assessment). As briefed to the SIGAR on-site team, the QAR indicated that the USACE and the contractor were aware of the deficiencies, and when weather permitted, corrective actions were being affected.

b. Quality Assurance reports provided to the SIGAR team describe in detail the on-going corrective measures, which specifically conform to the SIGAR's recommendations.

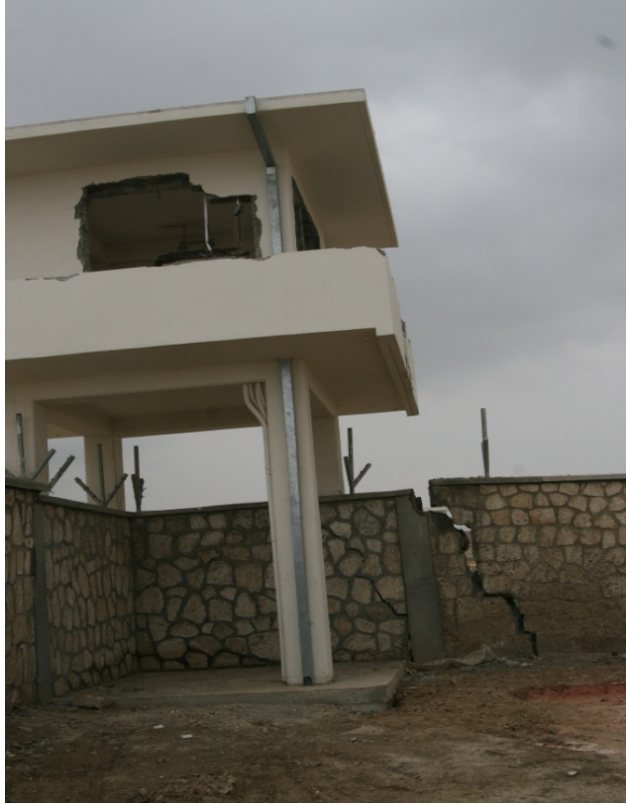
Photo 3: Guardhouse and Wall on Soil that Has Settled at Kunduz ANA Garrison

The most serious quality control issue observed on our January 2010 site inspection was severe settling of the soil under several structures following a rainfall in December 2009. We observed several areas where structures were damaged and unusable as a result of settling. For instance, photo 3 shows the structural failure of a guard tower and adjacent stone wall caused by the settling. Furthermore, the roadbed at the adjacent intersection had also settled, and we observed a large area that appeared to be collapsing into a cavity under the roadbed at this intersection (see photo 4) and at other locations throughout the construction site. AED-North officials at the site stated that a large pool of water had been at the roadbed intersection where we saw the severe settlement. This area was at the low end of the site and rough grading had directed the rain water to this area.

USACE Response: CONCUR. The USACE Resident Engineer Office and contractor are pursuing the appropriate resolution to this problem. Responding to these corrective actions, DynCorp is revising their drainage plan and is currently correcting the contract deficiencies caused by soil subsidence. See enclosed fact sheet.

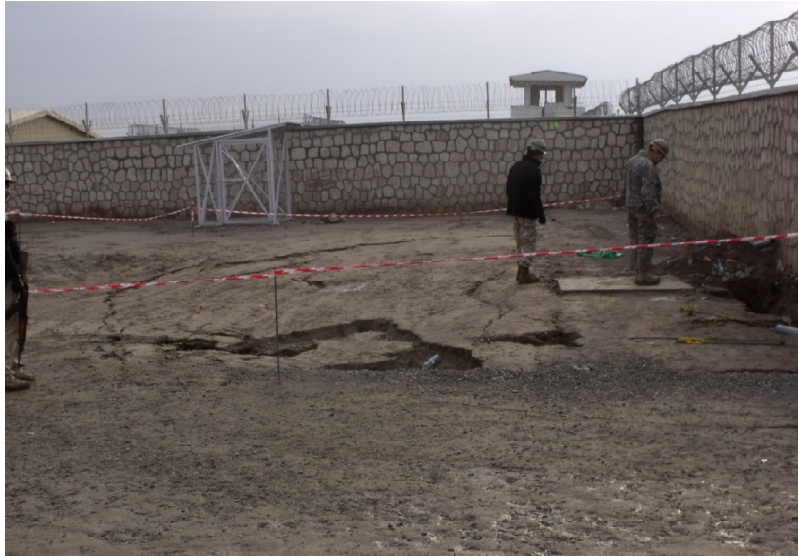
Photo 5: Settling along the Embedded Training Team Compound Wall at Kunduz ANA Garrison

In January 2010, the Resident Engineer (RE) for AED-North stated that DynCorp had submitted a request in December 2009, to modify the contract due to “differing site conditions” to cover the costs of repairing the damages resulting from the settling. AED-North denied the request but was investigating the causes of the settling. Following our site inspection, we reviewed three AED-North reports about the Kunduz soil issues,¹¹ which indicated that the probable cause for the severe settling is a lack of adequate site preparation before constructing the buildings. According to these reports, the soil at the site appears to have the characteristics of collapsible soil (see photos 5 and 6).¹² One report noted that an AED-North official spoke with a German Provincial Reconstruction Team engineer who stated that the Germans were aware of the special nature of the soil. This report notes that the Germans conducted a soil study in 2004 and found that the soil in Kunduz was a collapsible soil.

¹² Collapsible soil consists of loose, dry, low-density materials that collapse and compact if exposed to water, such as pooling after a heavy rainfall.

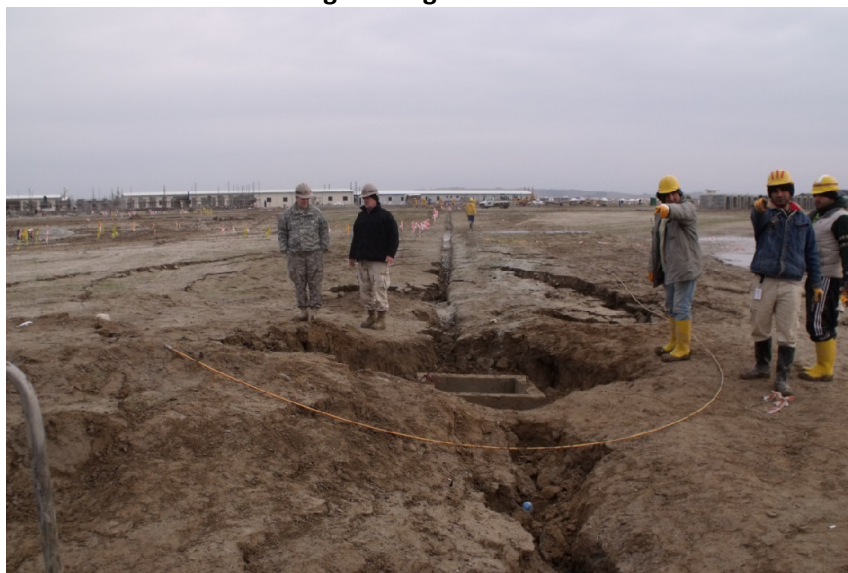
Photo 6: Roadbed Showing Settling at Kunduz ANA Garrison

This problem is further exacerbated if the site grading or slope is not sufficient to carry away excess water. The December 2009 AED-North report noted that the rainfall that month caused severe soil settling at 42 locations on the Kunduz garrison construction site. According to a December 2009 letter addressed to AED-North from DynCorp, as many as 48 sites in and around the garrison show signs of collapsed soil. In February 2010, we noted that the condition appears to be present throughout the garrison site and future rainfall will likely cause the soil and additional areas to collapse, jeopardizing other structures. In April 2010, we had further discussions with DynCorp and AED-North officials. While both AED-North and DynCorp agree that the soil under the site is a collapsible soil, they have not agreed on a course of corrective action.

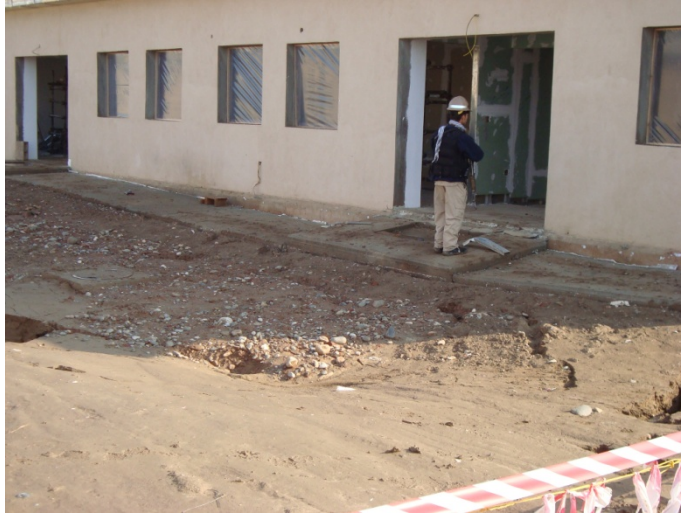
Photo 7: Lack of Grading that Contributed to Soil Settling at Kunduz ANA Garrison

The contract requires a site grading plan for drainage and that foundations must be at least 6 inches higher than the surrounding terrain to ensure that rainwater will drain away from the structure. Because the Kunduz garrison construction site is relatively flat, proper soil grading is essential. However, we noted the grading at the site was inconsistent and would not enable rainwater to run off the site. As a result, the soil issues described above were likely exacerbated. Photo 7 shows an area around a building where the grading does not meet the contract requirement for drainage. The photo also shows an area where the collapsible soils have been exposed to rain water and collapsed approximately 6 to 12 inches below the sidewalk. If left uncorrected, future rainfalls will further damage this structure.
